Rustling noises in the area of the timing chain, variable camshaft control (VANOS), camshaft in cold running mode up to an engine speed of 3,000 rpm.

E34, E36/M50

E36/M52

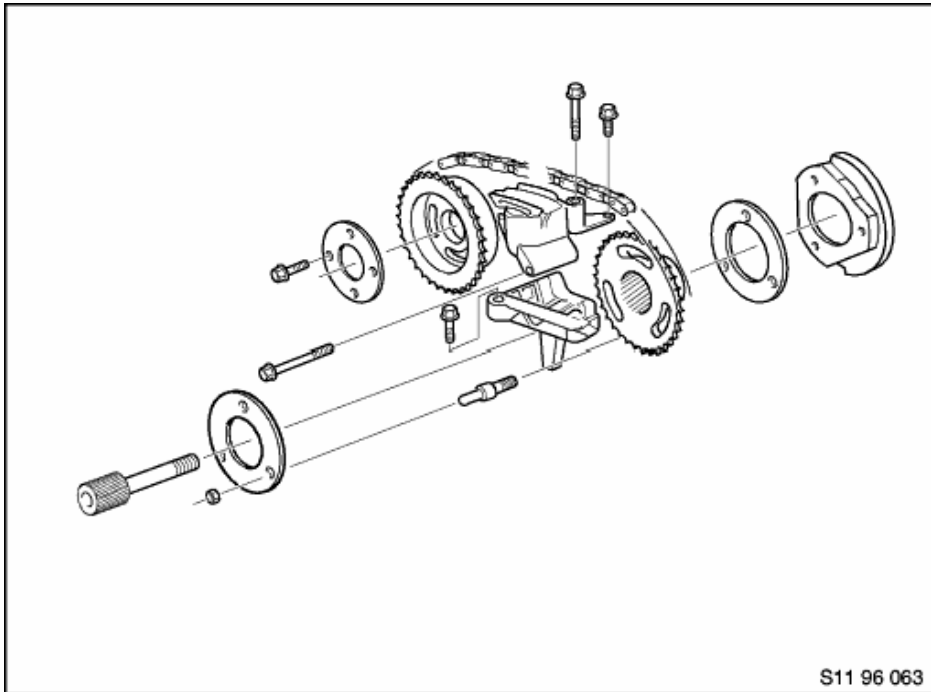
Fig. 2:

Excessive clearance between the thrust washer and the inlet camshaft sprocket wheel.

Variable camshaft adjustment - old version without plate springs up to June 1995

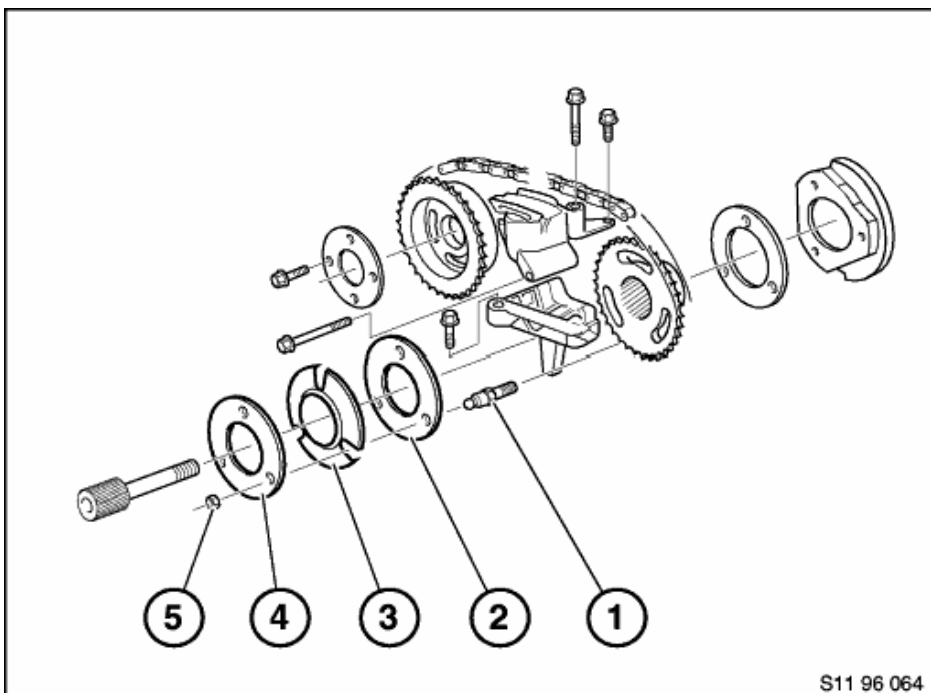
Fig. 3:

Variable camshaft adjustment - new version with plate springs since June 1995

- 1) Stud bolt
- 2) Thrust washer 2 mm
- 3) Plate spring
- 4) Thrust washer 4 mm
- 5) Nut

- Remove cylinder head cover.
- Remove VANOS adjustment unit.
See M50 repair instructions - 11 36 010
Please refer to M52 repair instructions - 11 36 010
- Remove inlet camshaft sprocket wheel.
- Install 3 new stud bolts (Fig. 3, item 1).
Application torque: 5 Nm
Joint torque: 22 Nm
- Reinstall sprocket wheel.
- Fit on thrust washer, 2 mm thick (Fig. 3, item 2).
- Fit on plate springs (Fig. 3, item 3). Note installation direction of plate springs: fit with the large support diameter facing the camshaft.
- Fit on thrust washer, 4 mm thick (Fig. 3, item 4).
- Screw on hexagon nuts (Fig. 3, item 5), using Loctite 273 screw locking varnish.
Tightening torque: 10 Nm
- Install VANOS adjustment unit
